Effect of Electrical Power line length on Faults occurrences in Electrical Distribution System- A case study of Ayede 132/33kV substation

Abstract: The paper examined the state of distribution network and analyzed the main causes of faults using Ayede 132/33kV as a case study. At the time of the study, the state of the major electrical facilities for 33kV distribution system was assessed to exploit information available related with the causes of faults. In addition, frequencies of faults occurrences on the feeders emanated from the substation as well as their lengths were obtained and were compared to know the effect of length of feeder on number of fault occurrence. In view of the findings during the cause of investigation, it is evident that the physical equipment needs urgent rehabilitation. Likewise, lengths of some feeders are too long compared to the magnitude of power they are transporting and required higher voltages for transmission.

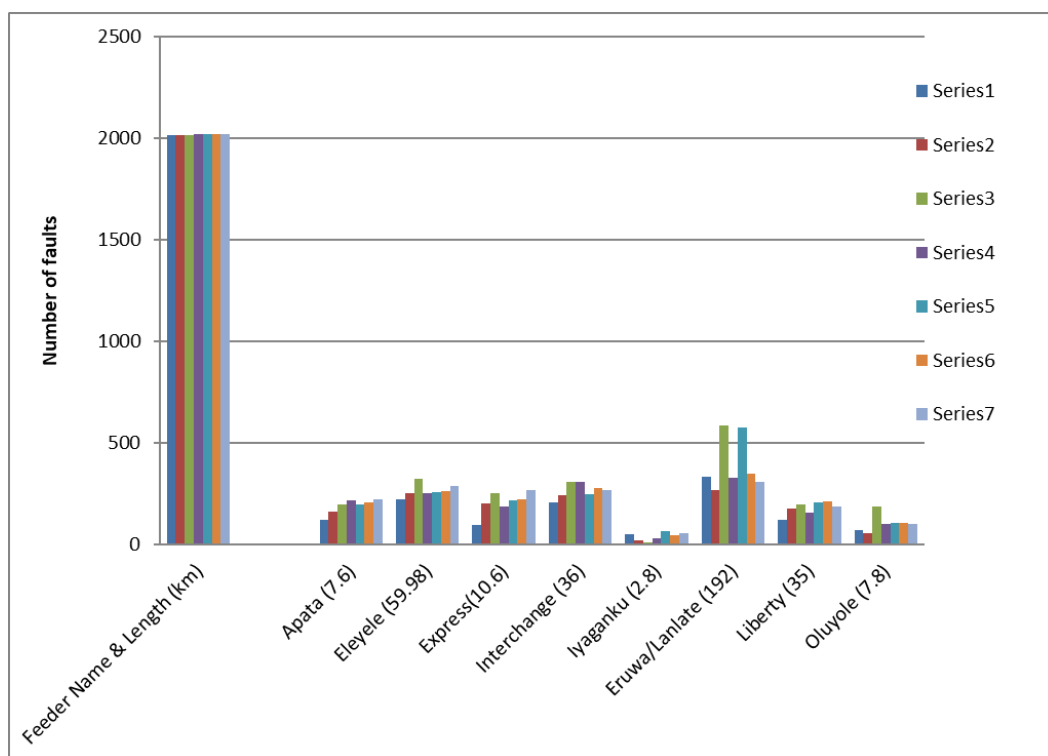
Figure 2: Comparison of feeders’ length and yearly fault frequency

Table 18 showed the summary of yearly faults occurrences and length of each feeder. Figure 2 showed graphical representations of relationship between feeders' lengths and the frequency of faults in each year. Table 18 showed that the number of faults occurrences increases as the length increases. Eruwa/Lanlate feeder is the longest feeder (192km), followed by Eleyele feeder (59.98km), Interchange feeder (36km) and Liberty feeder (35km) to mention few. In 2015, Eruwa feeder recorded 333 numbers of faults occurrences and Eleyele, Interchange and Liberty recorded 220, 203 and 120

numbers of faults respectively. In 2017, Eruwa, Eleyele, Interchange and Liberty had 586, 323, 306 and 193 numbers of faults respectively. In 2020 and 2021, the number of faults occurrences on Eruwa, Eleyele, Interchange and Liberty are 349, 260, 274 and 210 as well as 305, 288, 268 and 186 respectively.

The longest feeder recorded highest number of faults occurrences and the shortest feeder recorded the lowest number of fault occurrences. This implies that the number of faults occurrences is directly proportional to the feeder’s length. Based on the results obtained in this work, the following are recommended.

- ii. The energy provider should be creative enough to see the effects of faults and its economic value in the sub-station and be innovative in their approach so as to reduce the losses.
- iii. Where feeders are too long, e.g., Eruwa/Lanlate feeder, use of FACT devices should be encouraged.
- iv. Constant clearing of the “right-of-ways” in Ayede 132/33kV sub-station feeders.
